**Custom Care Cleaners
Site Inspection**

Vancouver, Washington

Technical Direction Document Number: 13-09-0005

July 2014

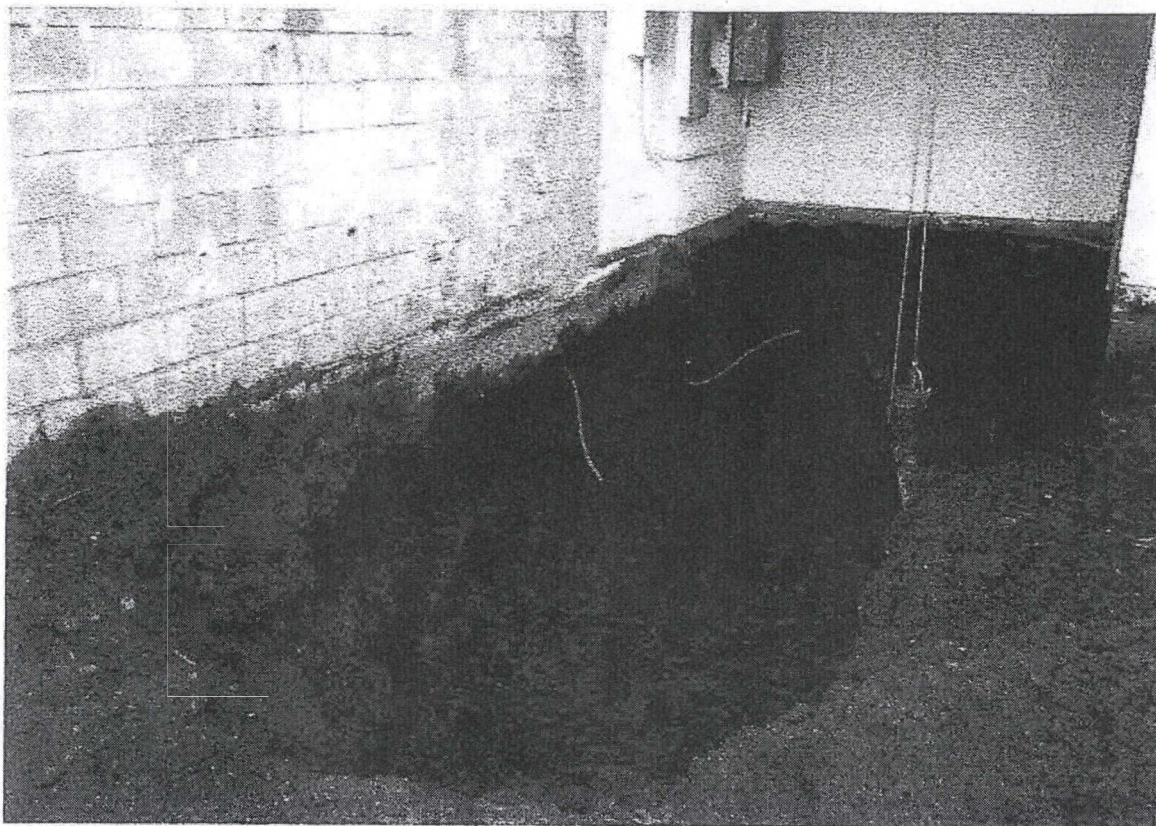
South UST Excavation

One 1,000-gallon UST was removed from the subsurface near the south side of the current dry cleaner business. Soil staining was observed around the fill tube, along the top of the UST and near the north side wall of the excavation. Petroleum odors were also observed. Groundwater was not observed within the excavation.

The UST was inspected for signs of damage. There was corrosion of the UST surface, but no indication of holes, cracks or evidence of poor structural integrity. However the UST appeared to be stained by petroleum product. Photographs of the USTs subsequent to removal are presented in Appendix B.

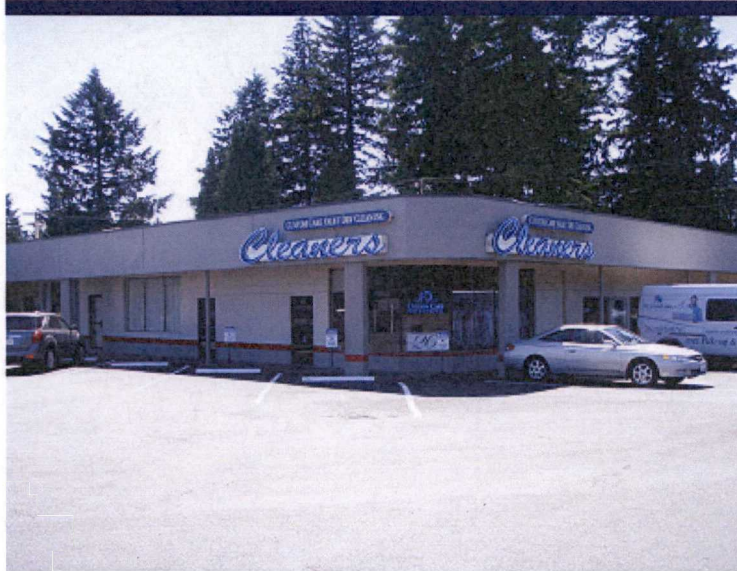
Photo 1 Northeast corner of Custom Care Cleaners. Retail entrance and counter are in photo.

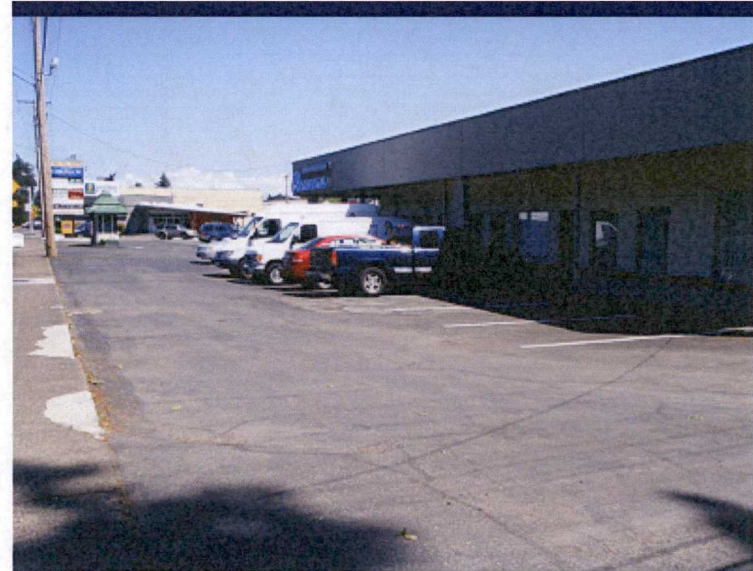
Photo 2 North side of Custom Care Cleaners.

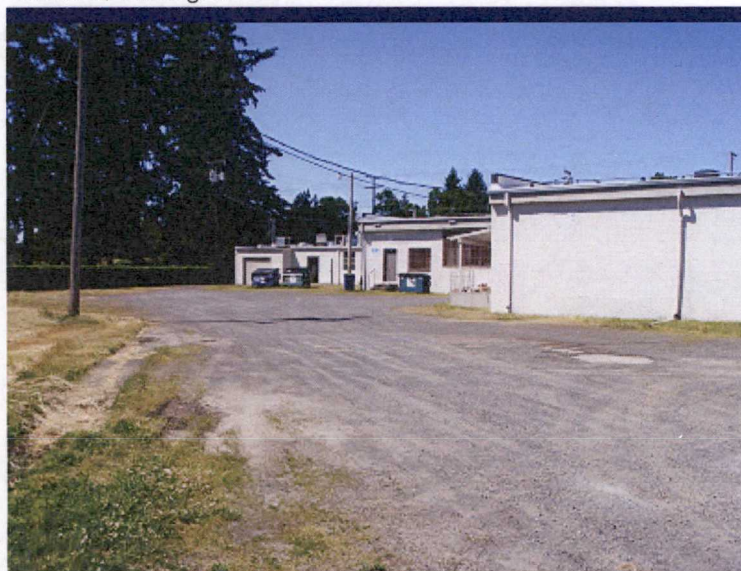
Photo 5 Southern side of Park Hill Shopping Center. Custom Care Cleaners and cemetery visible on far left side of photo.

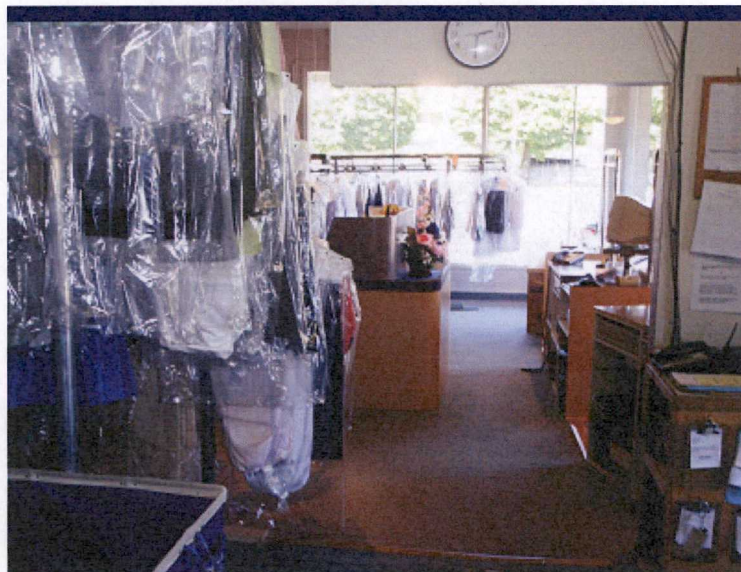
- Custom Care Cleaners occupies the western tenant space within the Park Hill Shopping Center building (Appendix B, Photos 1 through 6). The retail entrance, sales counter, and alterations area are located in the northeast corner of the Custom Care Cleaners tenant space (Figure 2-6; Photo 7). The remainder of the business area is occupied by sorting, pressing, and cleaning equipment.

Photo 7 Front retail counter and clothes storage in Custom Care Cleaners.

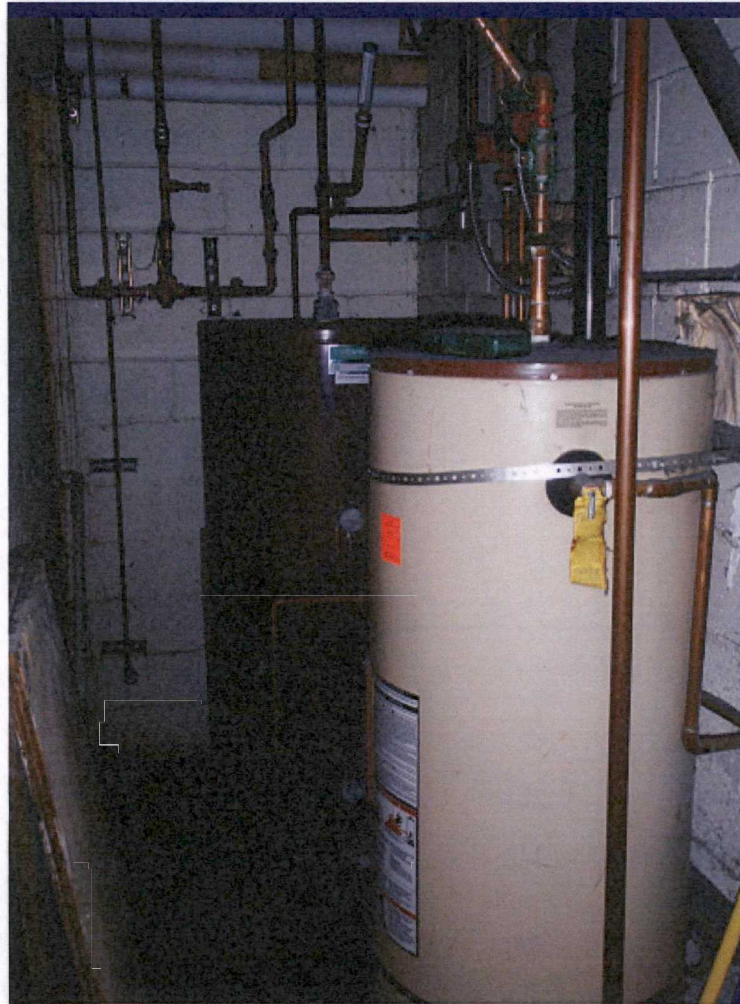
- Steam clothing presses are situated in the center of the Custom Care Cleaners building (Photo 8). Overhead steam lines were observed in this and other areas of the building, connecting to this equipment. Two water heaters and a boiler room with an outside access door were located on the southeast corner of Custom Care Cleaners (Photo 9).

Photo 9 Water heater/boilers near southeast corner of Custom Care Cleaners.

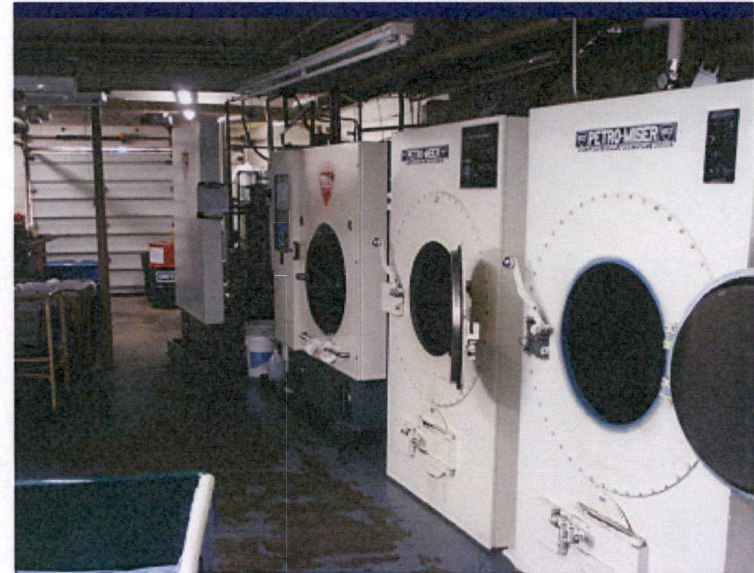
- The dry cleaning equipment is located in the southwest corner of Custom Care Cleaners, and includes three "Petro-Miser" brand machines (Photo 10). As previously discussed, Custom Care Cleaners currently uses DF-2000 or Ecosolv, both non-chlorinated, petroleum-based "green" dry cleaning solvents. Dry cleaning solvents are reclaimed by an attached still and carbon canister system located on the south side of the dry cleaning equipment (Photo 11). Several patches were observed on the exterior building wall behind these machines (Photo 18). All other machines in this area were standard washing machines that use soap and water. Filter containers, dry cleaning solvent drums, and other related supplies were located to the east of the dry cleaning machines (Photo 12). A variety of spot-cleaners were stored on a shelf, located adjacent to these containers. According to Mr. Ickert, the previously used dry cleaning equipment had also been located in this area.

Photo 10 Dry cleaning machines located in SW corner of Custom Care Cleaners. All use "green" dry cleaning solvent.

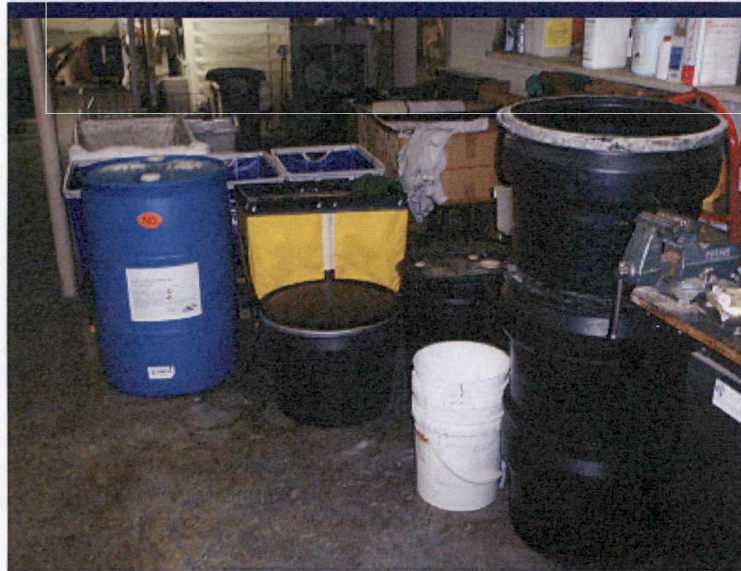
Photo 12 View of containers in southwest corner of Custom Care Cleaners, located near dry cleaning machines in Photo 10.

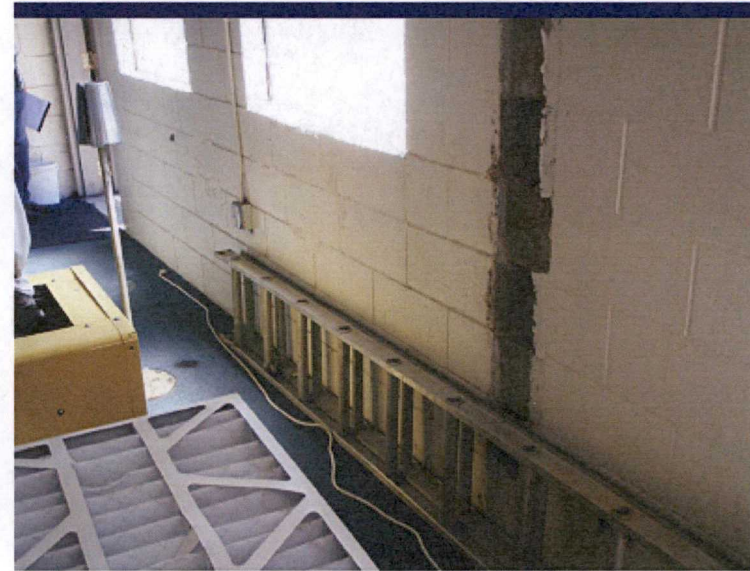
Photo 13 Inside of southern area of Custom Care Cleaners. Broken CMU blocks show south end of demolished n/s wall.

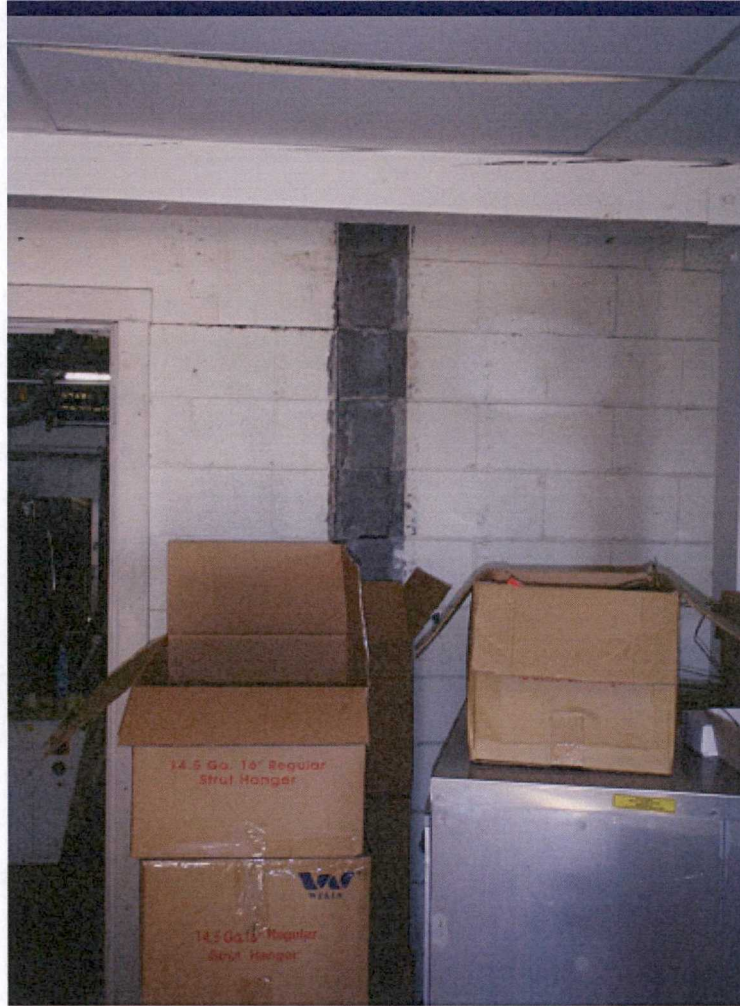
Photo 14 Northern edge of former N/S wall in southern part of Custom Care Cleaners.

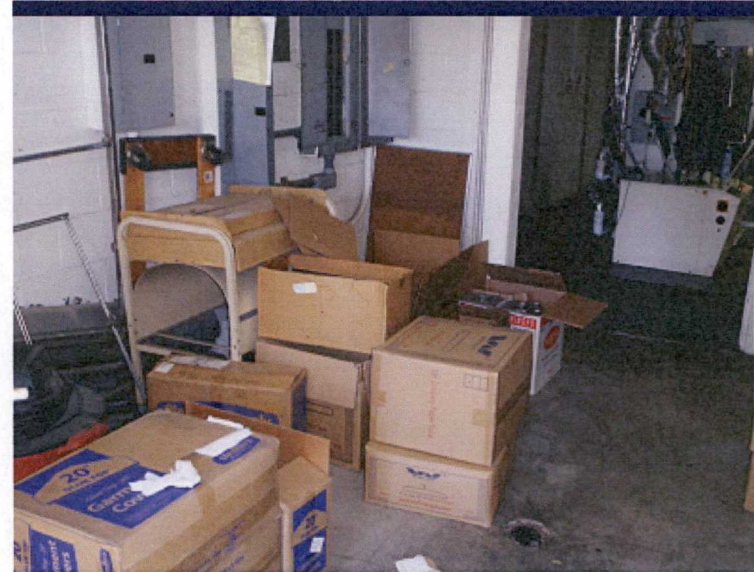
- Further, according to Mr. Ickert, the previously used Stoddard still and related equipment observed by Ecology had been located on the southern side of Custom Care Cleaners. A discharge pipe that had apparently been connected to the still ran through the wall to the buried drum located in the outdoor area, to which waste fluid had been discharged. As previously discussed, this was also the location where a 1,000-gallon heating-oil UST had been removed. According to Mr. Ickert, a plastic sewer cap set within the concrete approximately coincides with the previous location of the buried drum (Photo 15).

Photo 15 South addition to Custom Care Cleaners. Sewer cap visible. Breaker panels also visible in PNE's "South UST Excavation" photo.

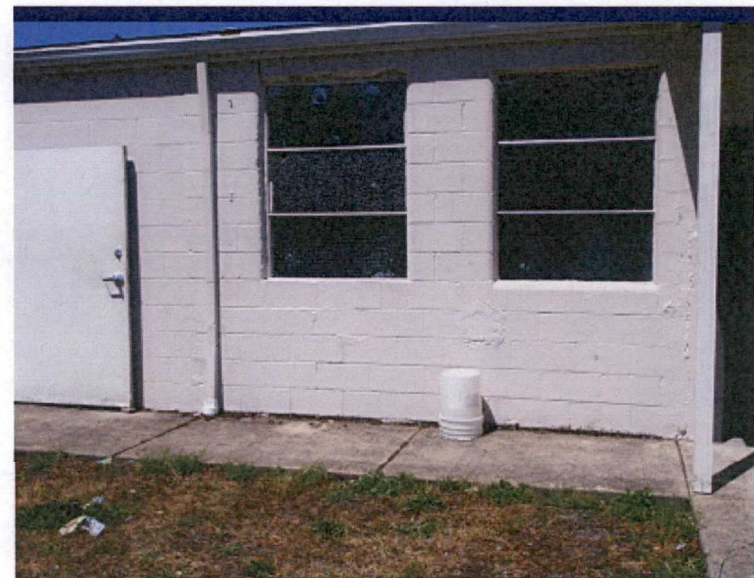
- Exterior patching was observed on the southern and western concrete masonry unit (CMU) exterior walls of the building. According to Mr. Ickert, dryers had previously vented through these holes (Photo 16).

Photo 16 South exterior of Custom Care Cleaners. Area left of downspout is location of new CMU wall. Patches are on right.

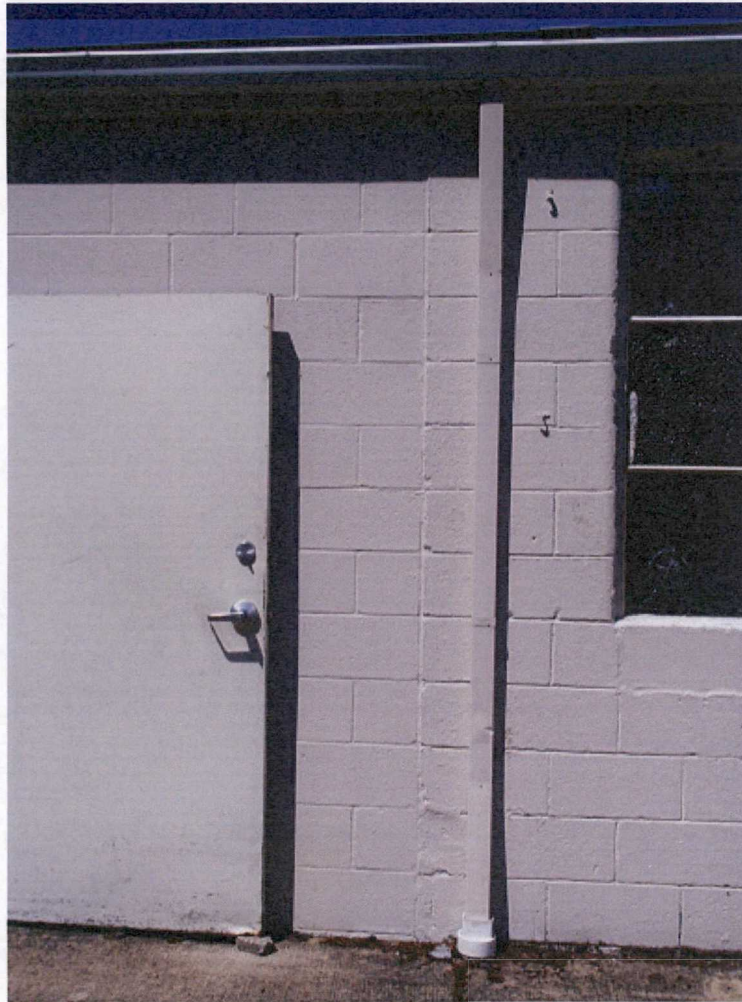
Photo 17 Closer, straight-on view of seam between new (left) and old (right) sections of southern Custom Care Cleaners exterior wall.

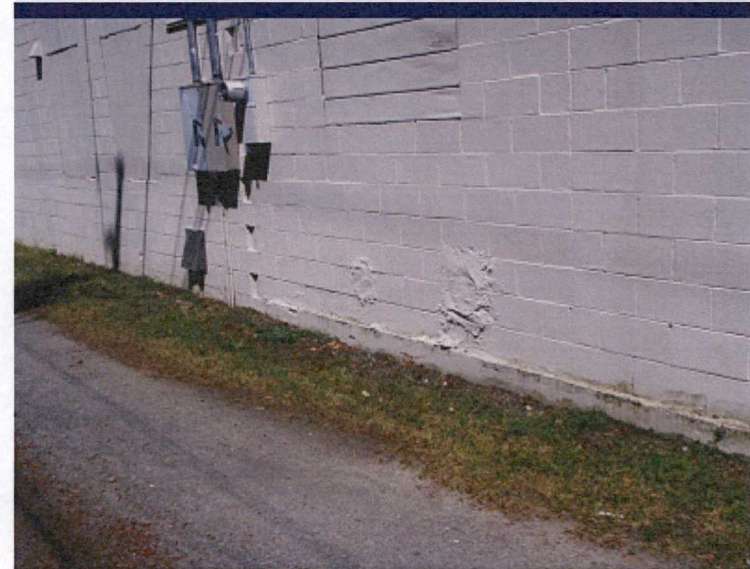
Photo 18 Additional patches on exterior of CMU wall for Custom Care Cleaners. Wall pictured is the western wall of tenant space.
